Subject: Report on Sealing of Slab Penetrations,

Former Siemens Facility

Intersil/Siemens Superfund Site

Cupertino, California

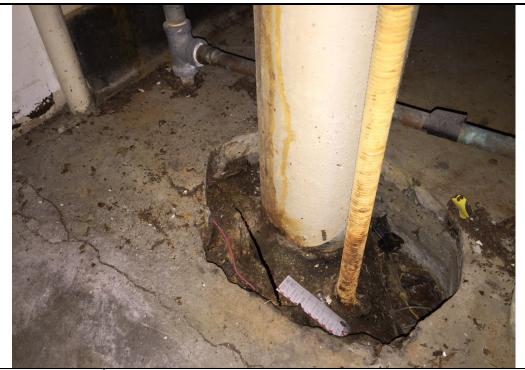
Photograph: 1A

View of the southern fire riser located at sampling location IA12, fire riser 1, before sealant was installed. The slab is about 4 to 6 inches thick at this location.

1) Great StuffTM, an expandable insulating foam; 2) AFM Safecoat
DynoSeal, a low-odor, waterproof, vapor-proof sealant; and 3) AFM
Safecoat DynoFlex Roof Guard, a mildew and water resistant coating.
Great StuffTM was used to fill the deeper floor slab penetrations at fire risers 1 and 2 that are located at IA12, which are 4 to 6 inches deep (see Attachment A). As presented in Photo 3A of Attachment A, fire riser 3

On 19 December 2014, the Great StuffTM sealant was sprayed into the two deep slab penetrations at fire risers 1 and 2 located at IA12. After initial drying time, excess foam was cut off with a serrated knife and the foam was left to fully cure for approximately 2 hours. Two coats of AFM Safecoat DynoSeal sealant were then applied to all three fire risers (fire risers 1 and 2 located at IA12 and fire riser 3 located at IA9). Ample time was left in between coats to allow for proper drying and sealing to take place. The AFM Safecoat DynoSeal was left to dry for four days before the final sealing product was applied. On 23 December 2014, two coats of AFM Safecoat DynoFlex Roof Guard sealant were applied on top of the cured AFM Safecoat DynoSeal sealant at each fire riser. The areas were secured and not disturbed while drying took place. Photos of the completed sealant installations are provided in Attachment A.

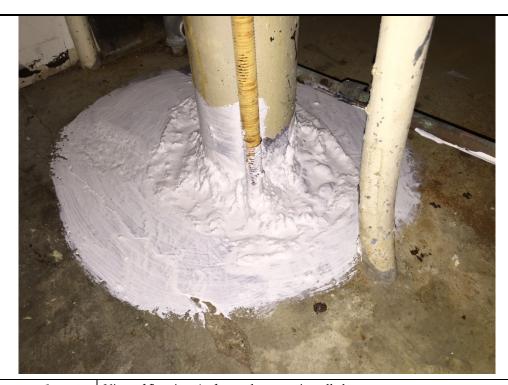
Photograph: 1B

View of fire riser 1 after sealant was installed.

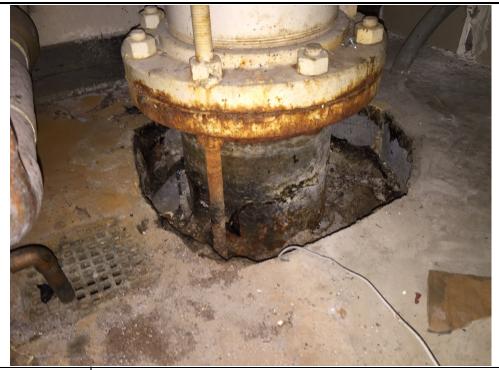
Photograph: 2A

View of the northern fire riser located at sampling location IA12, fire riser 2, before sealant was installed.

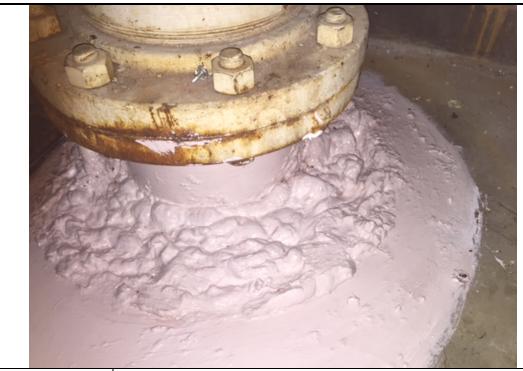
Photograph: 2B

View of fire riser 2 after sealant was installed.

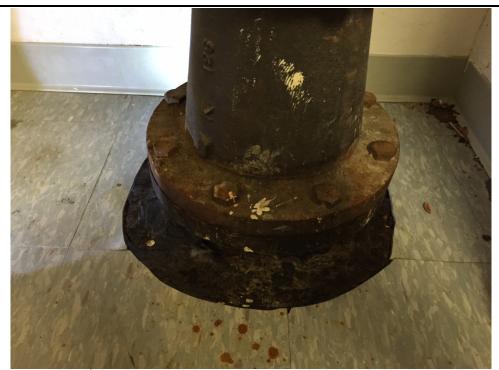
Photograph: 3A

that is located at the IA9 location that does not have a full floor slab penetration, therefore Great StuffTM sealant was not used at this location.

View of fire riser at IA9 location, fire riser 3, before sealant was installed. There is not a full slab penetration at this location, just a slight exposure below the laminate flooring.

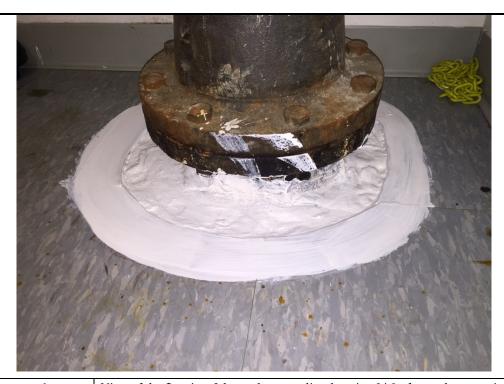
Photograph: 3B

View of the fire riser 3 located at sampling location IA9 after sealant was installed.
